# Garmin Nüvi 52LM USB Charge Port Replacement

This guide will show you how to replace the USB charge port on your Garmin Nüvi 52LM.

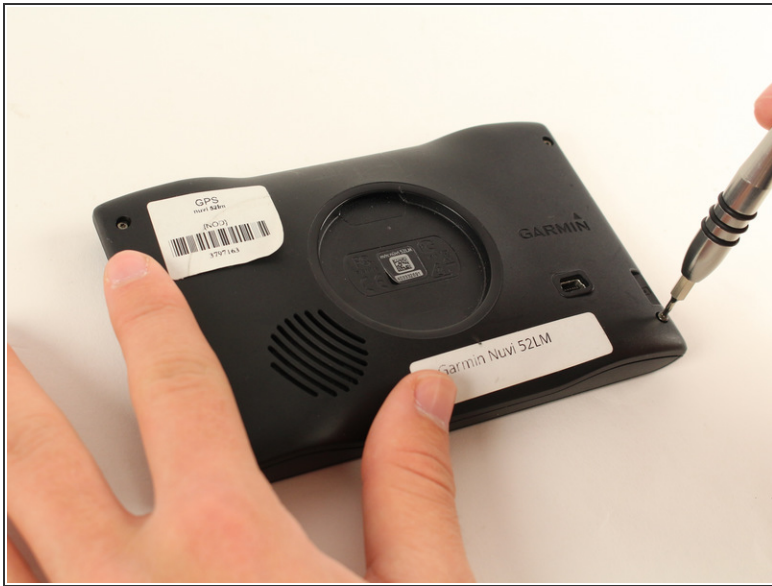
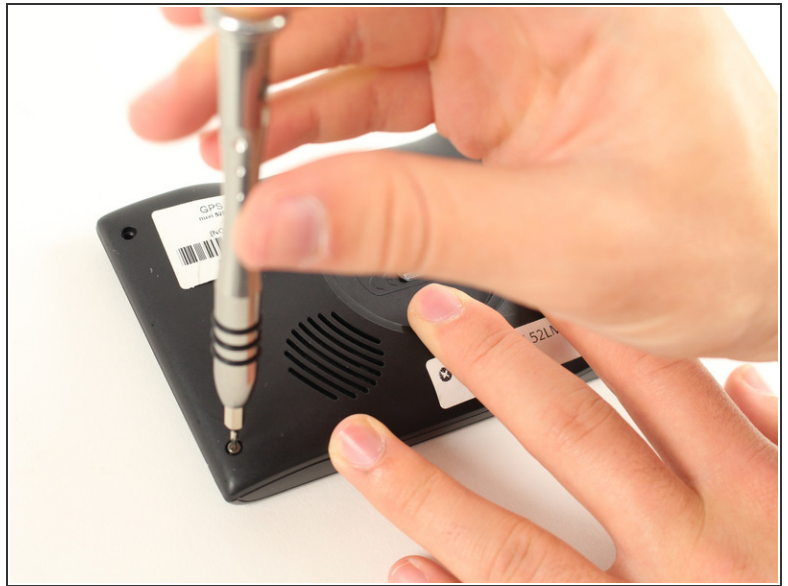
## Step 1 — Garmin Nüvi 52LM Disassembly

- Place the device face-down, with the screen facing the surface. There are **8.7mm** screws located in each of the back 4 corners of the device. Using a T5 Torx screw bit, unscrew all four screws and leave them aside.

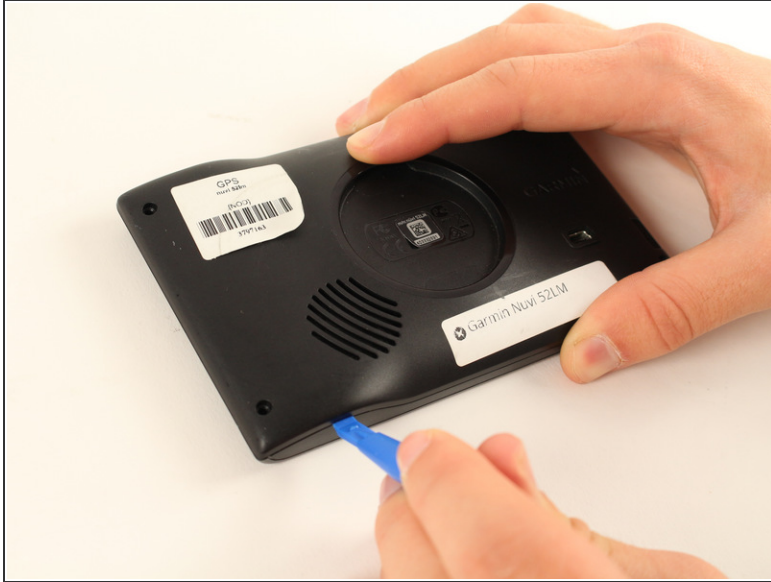
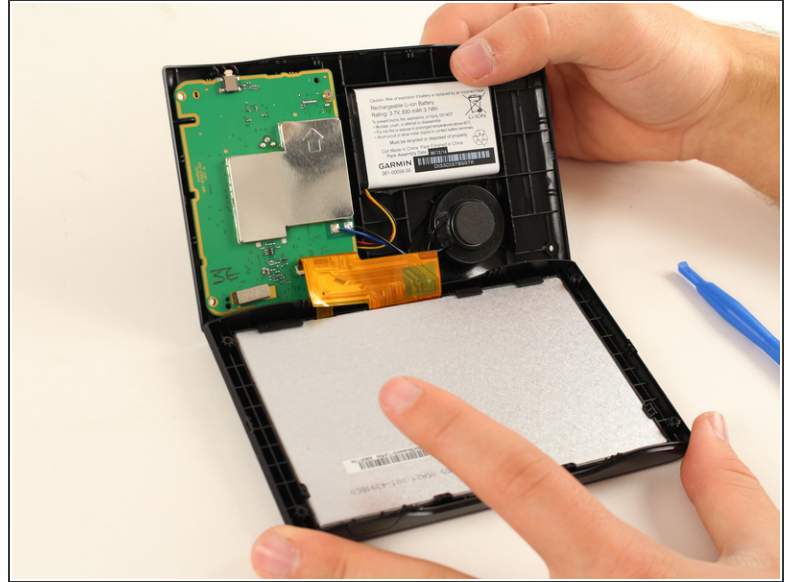
## Step 2

- Place a plastic opening tool in the seam between the back and front plates of the device. Using constant pressure, slowly and continuously slide the tool along the seam. The tool should disable each of the hooks holding the two plates together. If unsuccessful, apply slightly more pressure and try again.
- Once all hooks are disabled, slowly separate the two plates, being careful not to damage the ribbon wire still connecting the two.

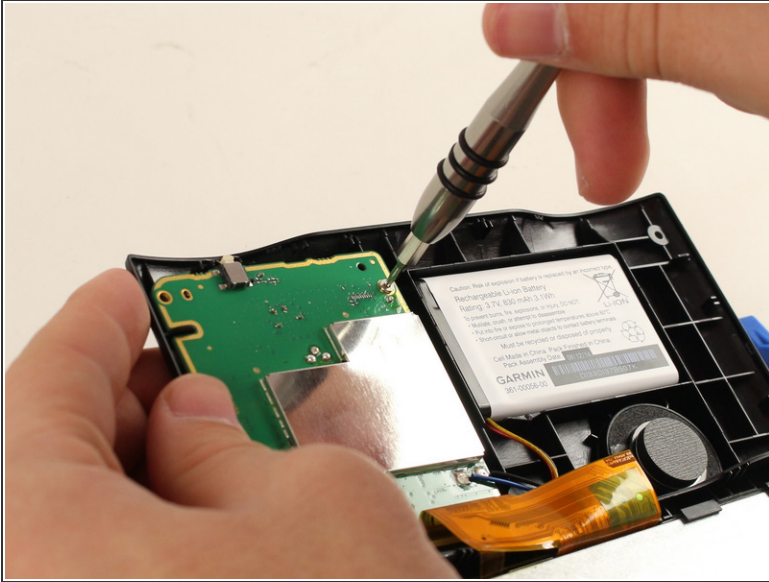
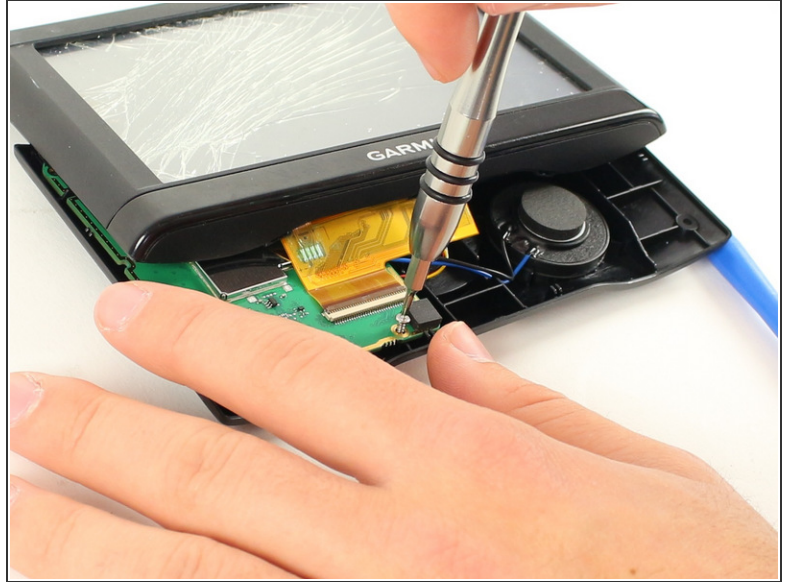
## Step 3 — Battery

- Using the T5 Torx screwdriver, unscrew the two **5.6mm** screws at the top right and bottom right corners of the motherboard.

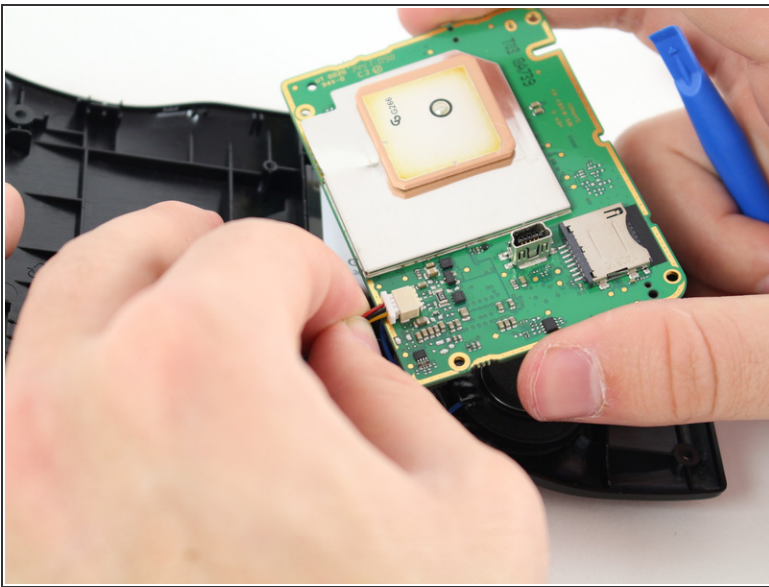
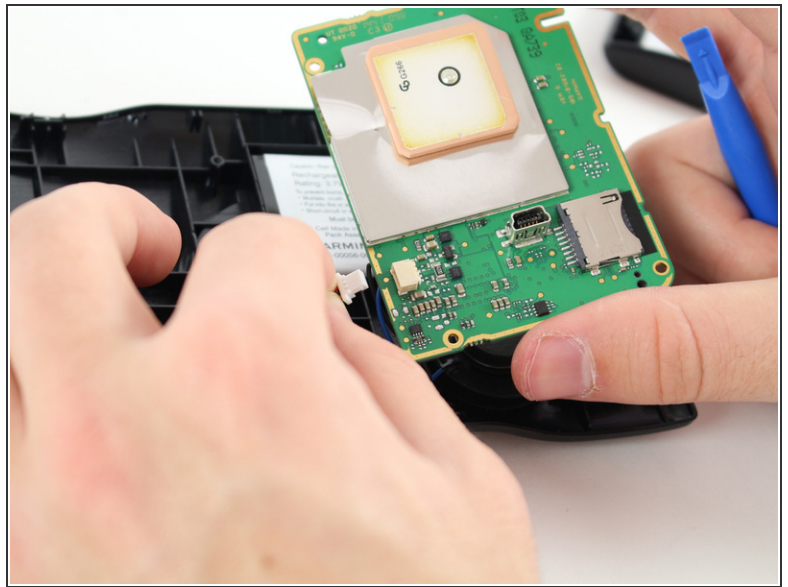
## Step 4

- Gently unplug the wire connecting the battery to the small socket on the back of the motherboard.

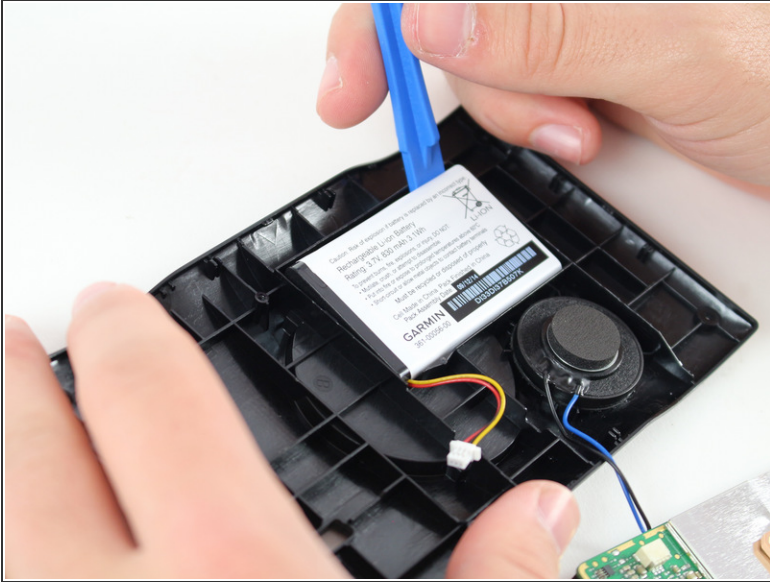
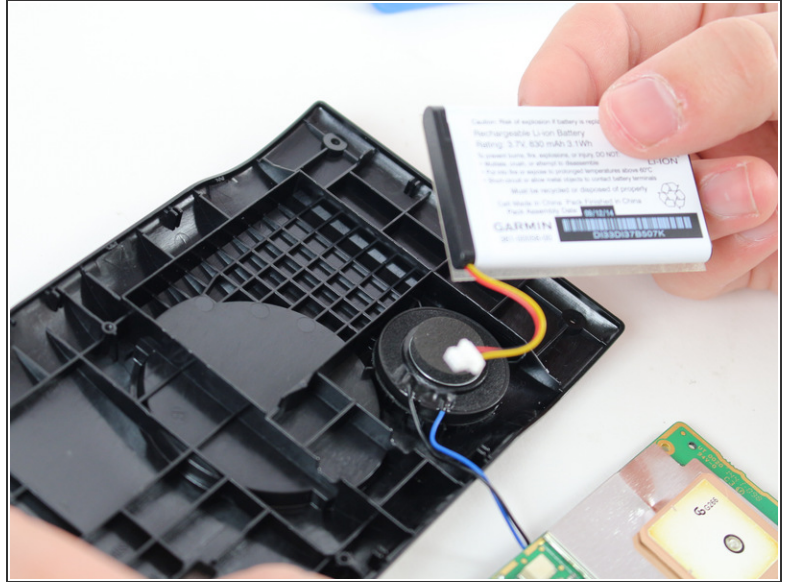
## Step 5

- Using a plastic opening tool, pry the battery from the back cover of the device. There may be an adhesive sticker keeping it in place, so you may need to apply some force.
- The battery should now be completely detached from the other parts.

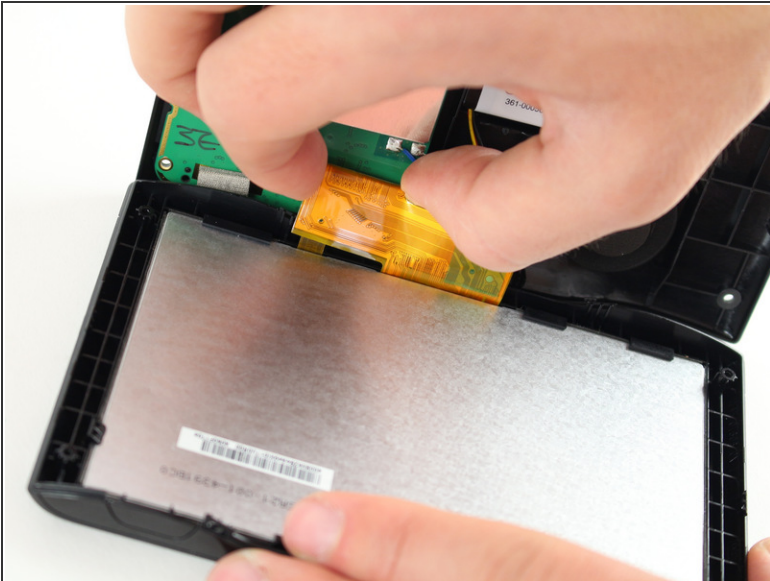
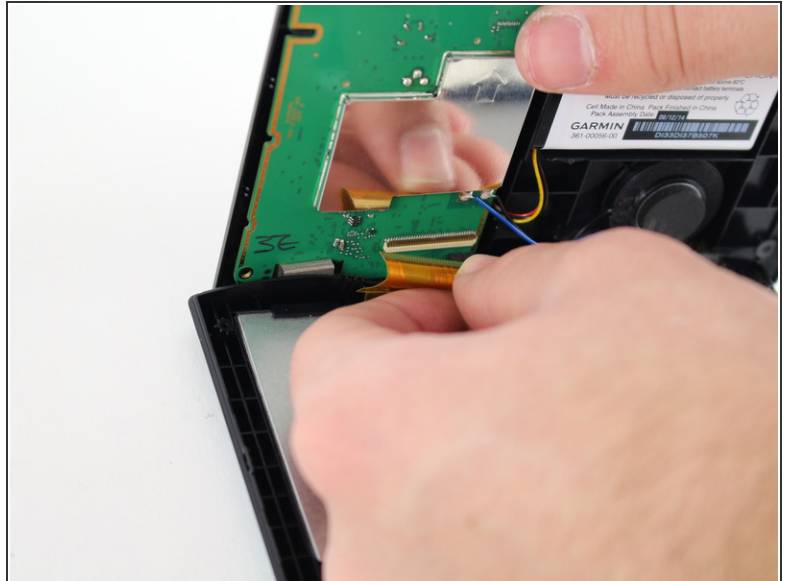
## Step 6 — USB Charge Port

- On the motherboard, lift the small plate that holds the orange ribbon wire in place.
- Gently disconnect the ribbon wire from its connection to the motherboard.

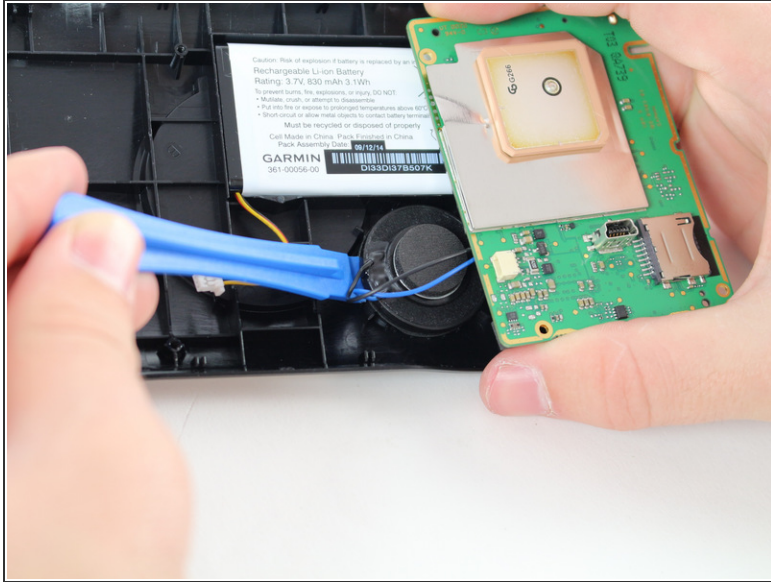
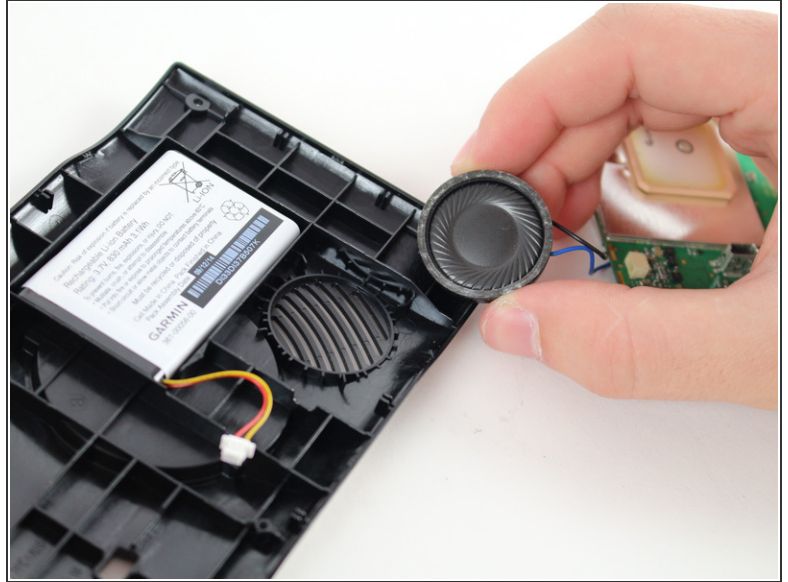
## Step 7

- Using a plastic opening tool, pry the speaker from the back plate of the device. There may be a small amount of adhesive connecting the two, so you may need to use a small amount of force.
- The motherboard and USB charge port should now be completely detached from the other parts of the device, and a new one can now be placed.
